LONG-TERM OPERATION OF A WATER
ELECTROLYSIS MODULE*

F. H. Schubert

TRW Mechanical Products Div.
Cleveland, Ohio

*This work is being supported under NASA Contract NAS2-4444, NASA CR-73355

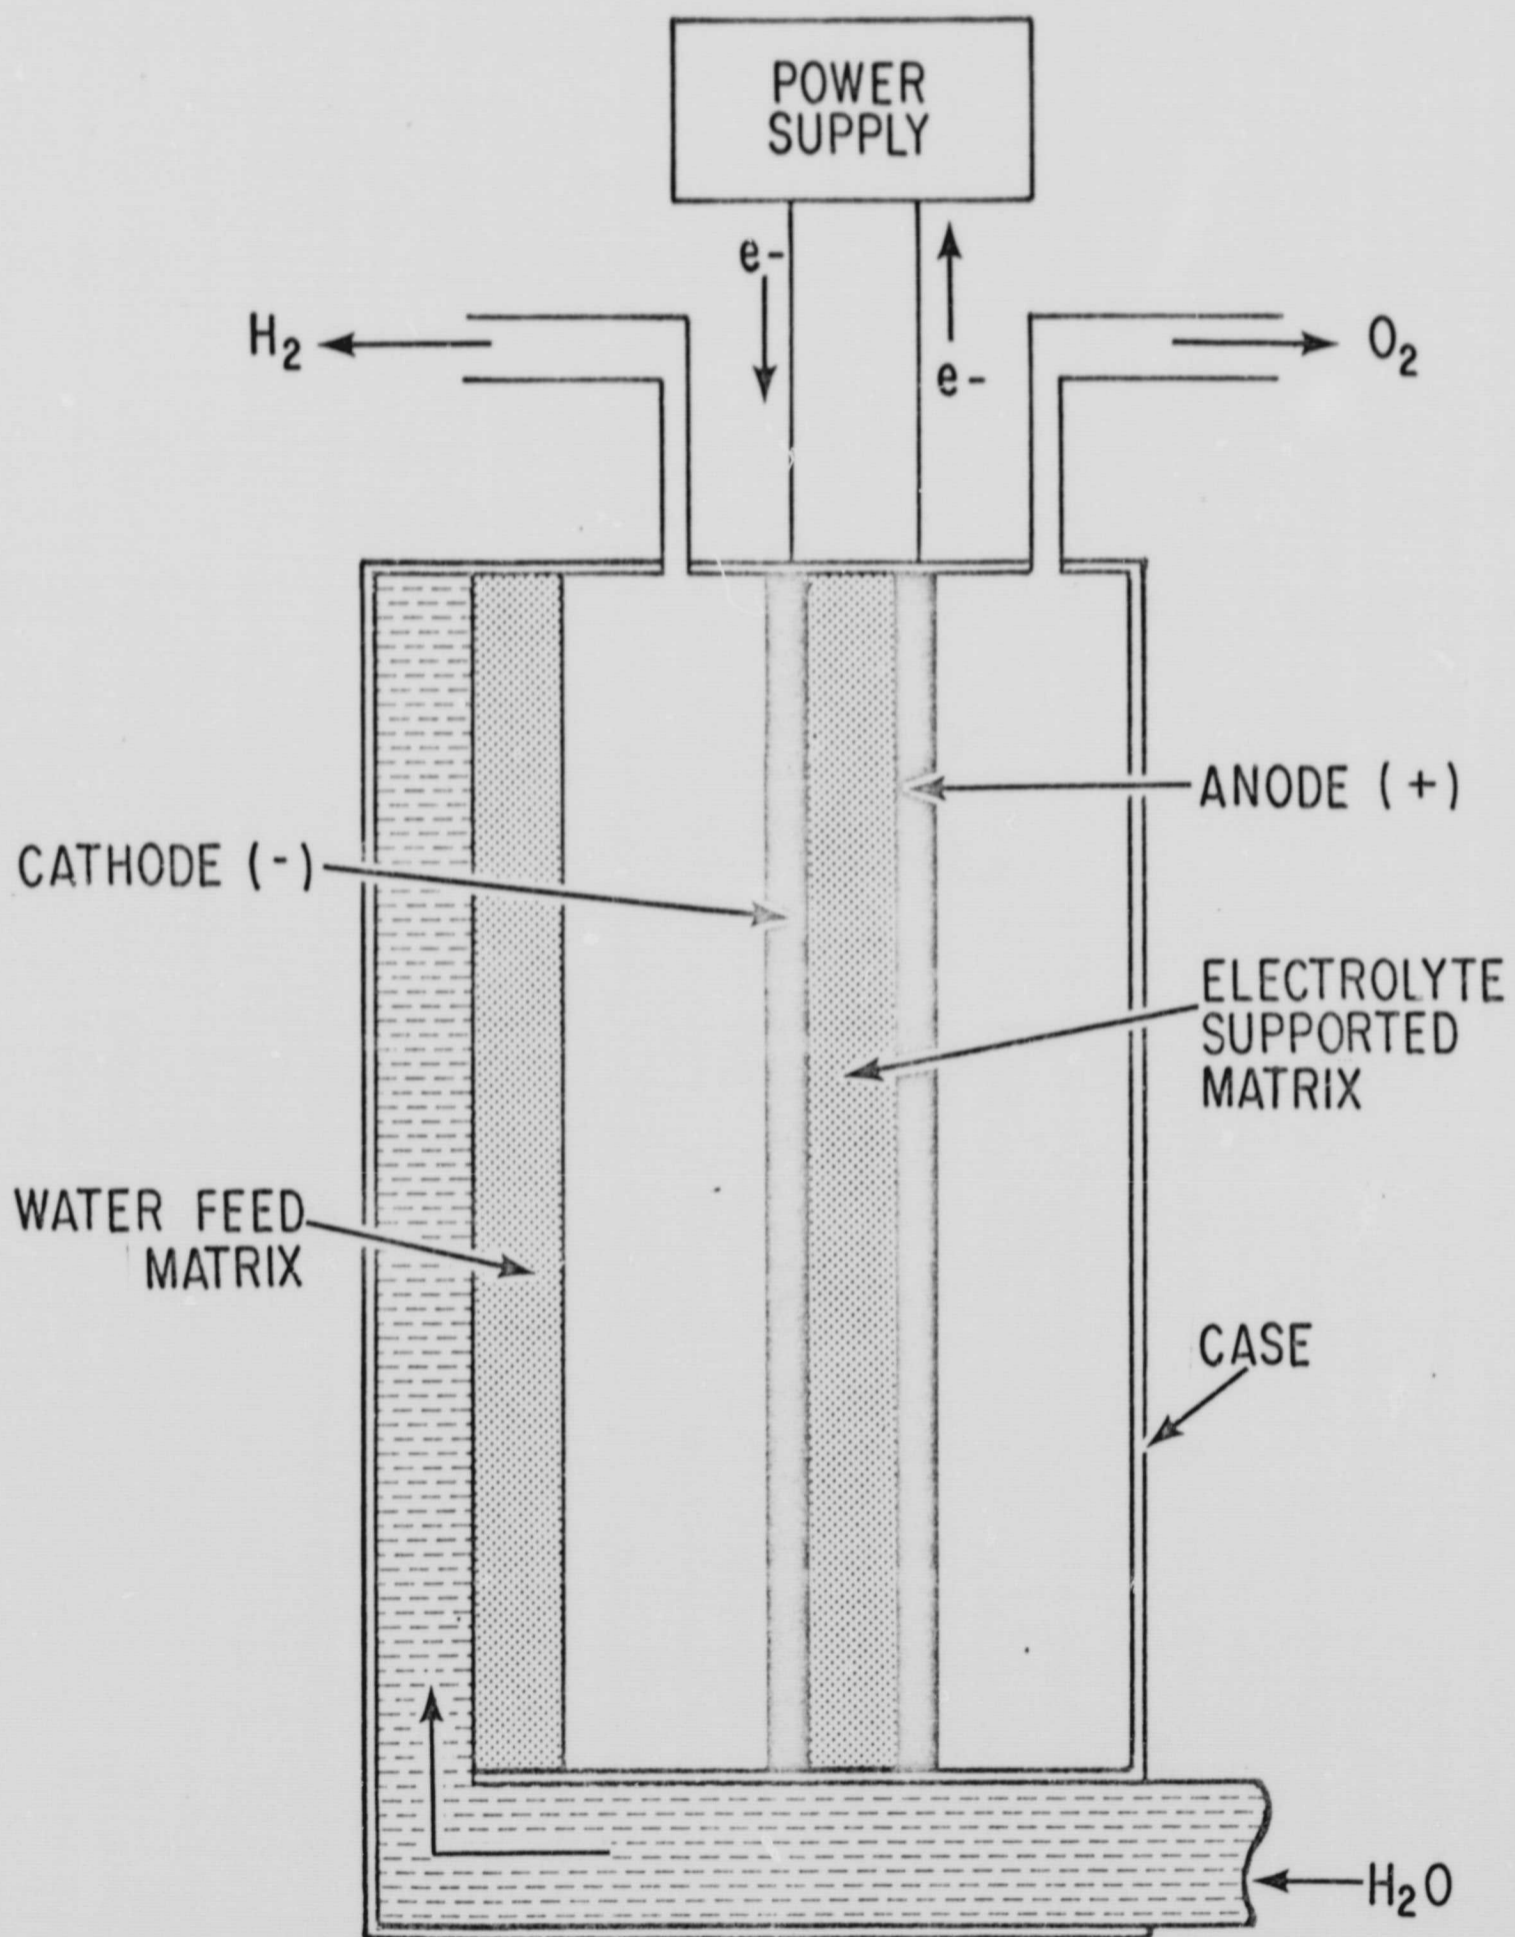
The resulting cell configuration is shown in Figure 1. The cell operates as follows. When power is applied to the electrodes, water from the cell electrolyte is decomposed. As a result, the concentration of the cell electrolyte increases and, therefore, its vapor pressure decreases to a level below that of the feed compartment electrolyte. This vapor pressure differential causes water vapor to diffuse from the feed membrane through the hydrogen cavity and

electrode into the cell electrolyte. This process continues as long as the vapor pressure of the cell electrolyte is lower than that of the electrolyte in the feed matrix. The transfer of water from the feed compartment to the cell matrix causes a decrease in volume or pressure level in the feed compartment which in turn draws make-up water into the feed cavity from an external reservoir.

One of the foremost considerations that governed the cell and stack design was to electrically isolate the feed water manifold and compartments from any electrical cell potential. This is essential for cells with static water feed systems since generation of gases within the feed cavities due to inter-cell electrolysis will lead to failure in the water feed mechanism.

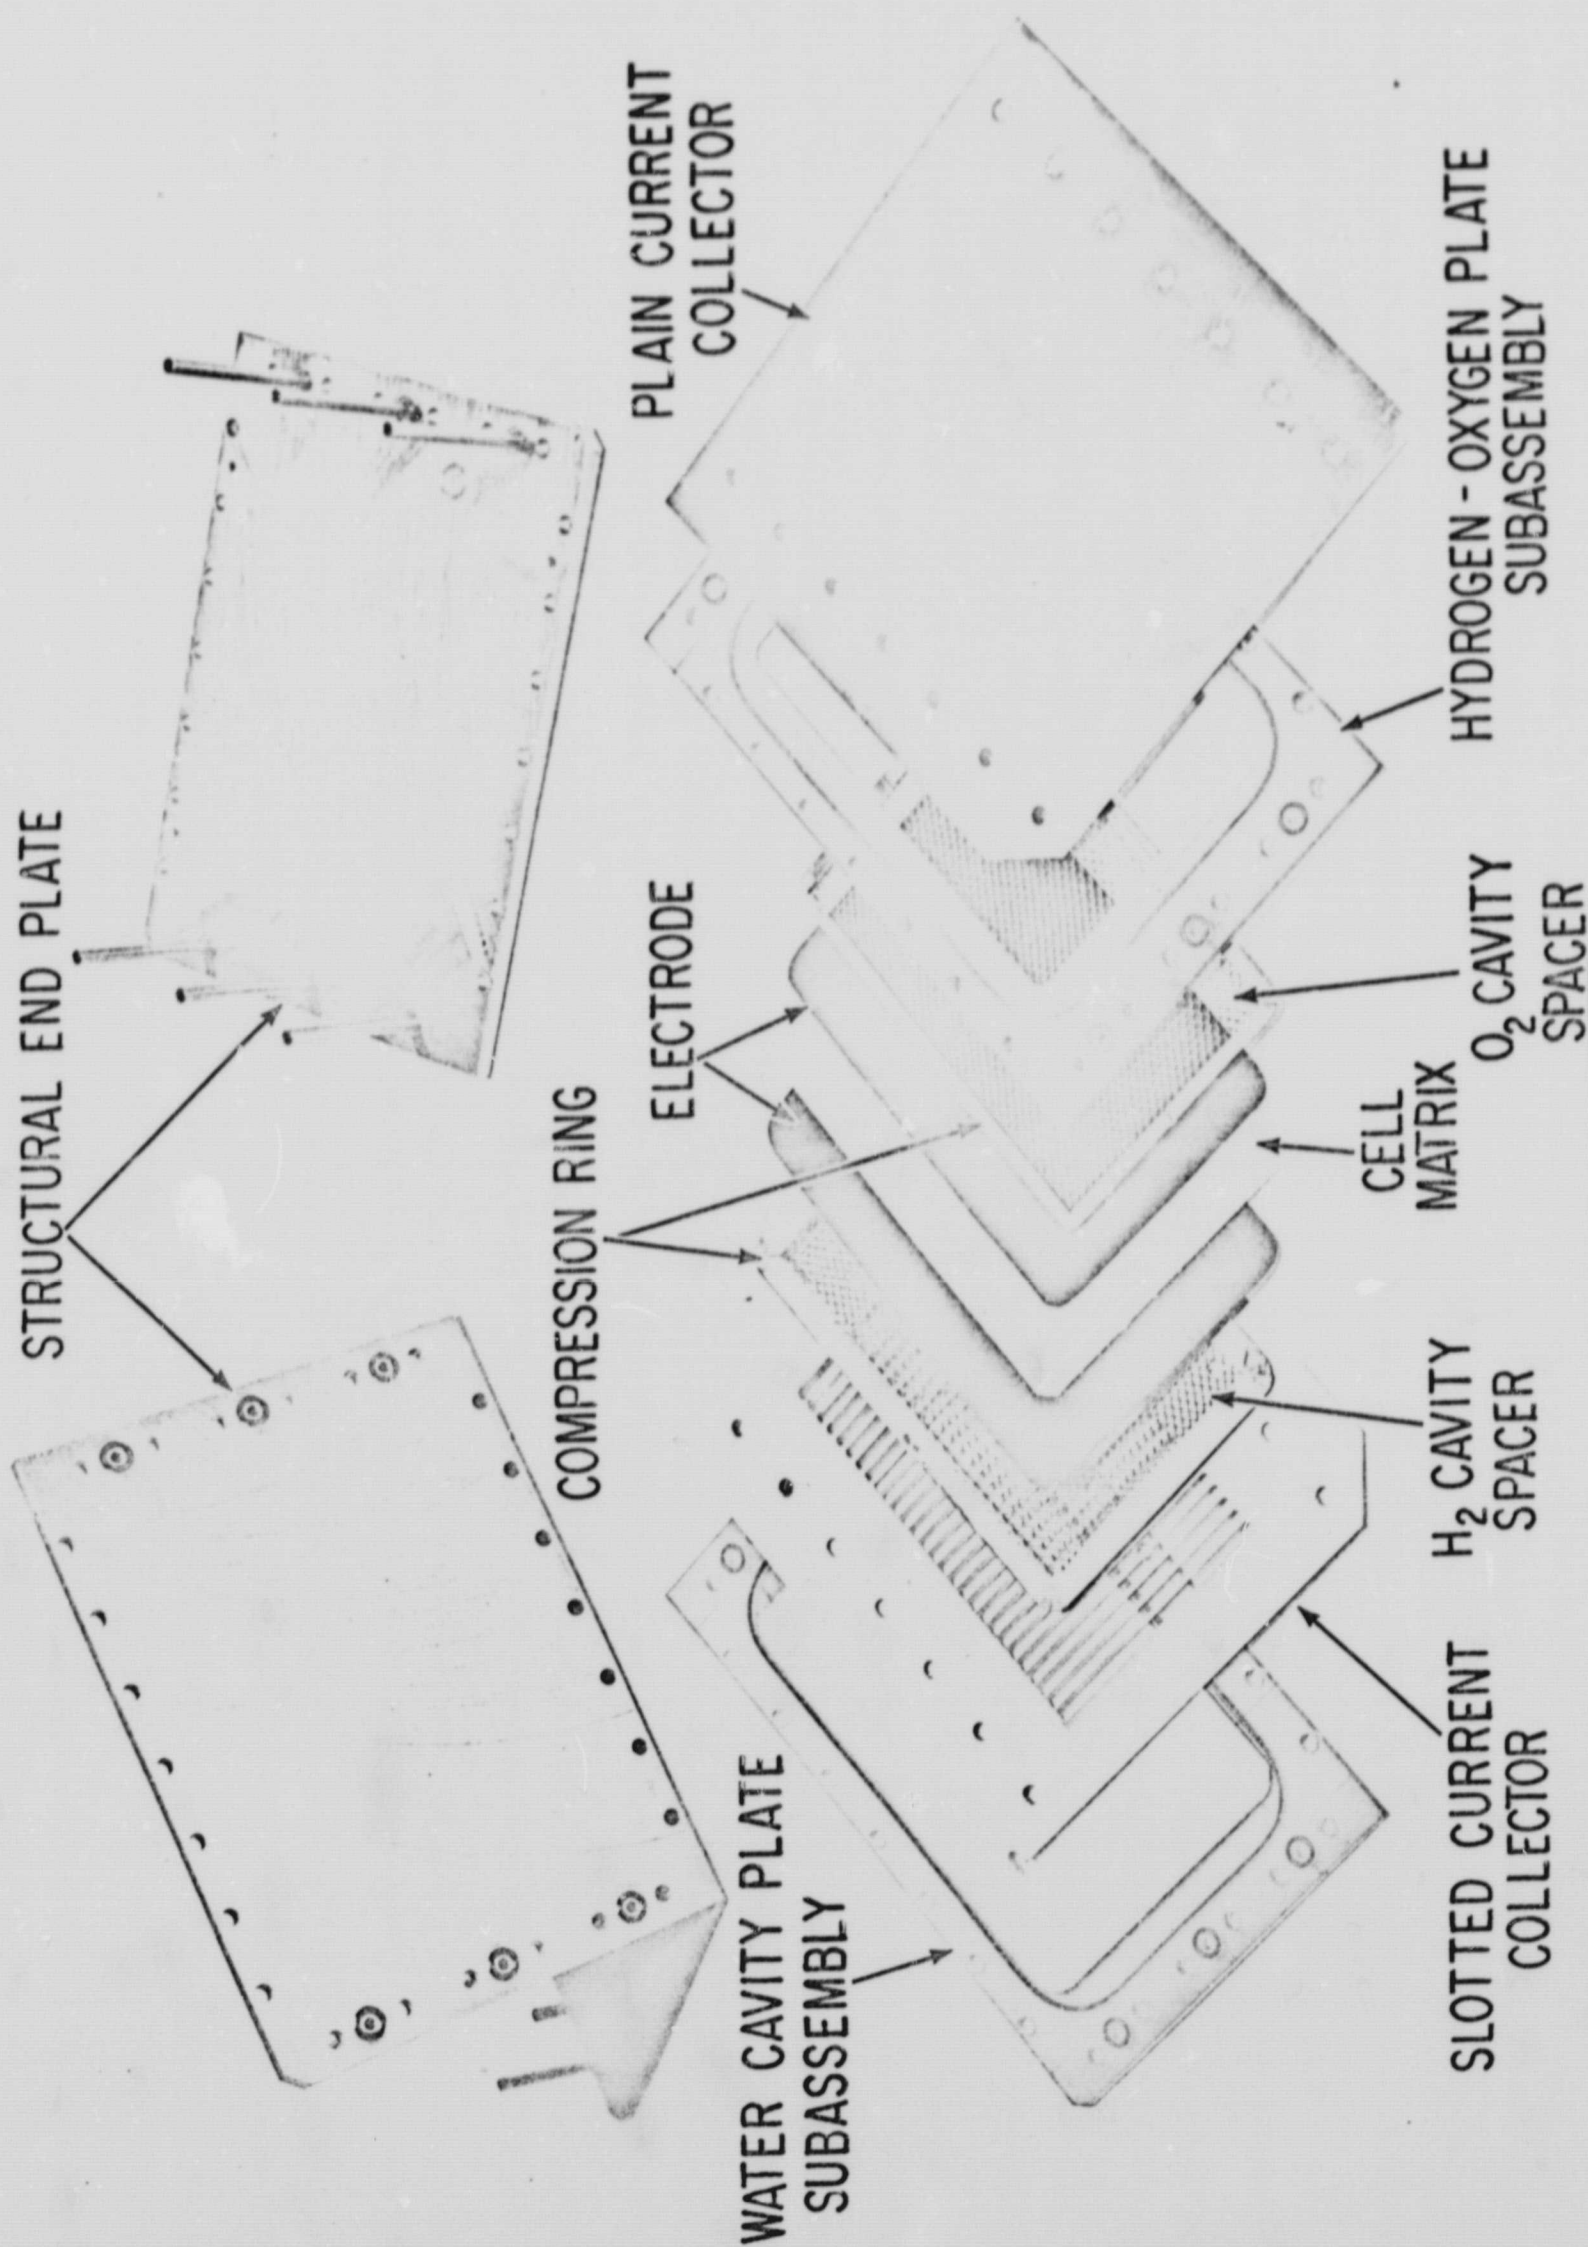
To generate the 0.15 lbs/hr of oxygen, a ten-cell stack electrically connected in series was selected. At a design current density of 100 amps/ft², an active electrode area of 330 in² (0.228 ft²) per cell is, therefore, required. Figure 2 shows the components that make up a typical unit cell. The structural endplates for the ten-cell WEM are also shown.

The materials of construction selected were polysulfone plastic for the water cavity and hydrogen-oxygen plates, high purity asbestos for the water feed matrix and the cell matrix, polypropylene plastic for the water cavity spacer and feed matrix support screens, expanded nickel for the hydrogen and oxygen cavity spacers and nickel for the compression rings. The electrodes were American Cyanamid Type AB-6. The current collector cooling fin combination plates were constructed from copper plated with 2.5 mil of nickel. The copper was selected because its high thermal conductivity facilitates removing the heat to the cooling fins. The nickel provides protection against the electrolyte environment. All cell and manifold sealing was accomplished with ethylene propylene O-rings.

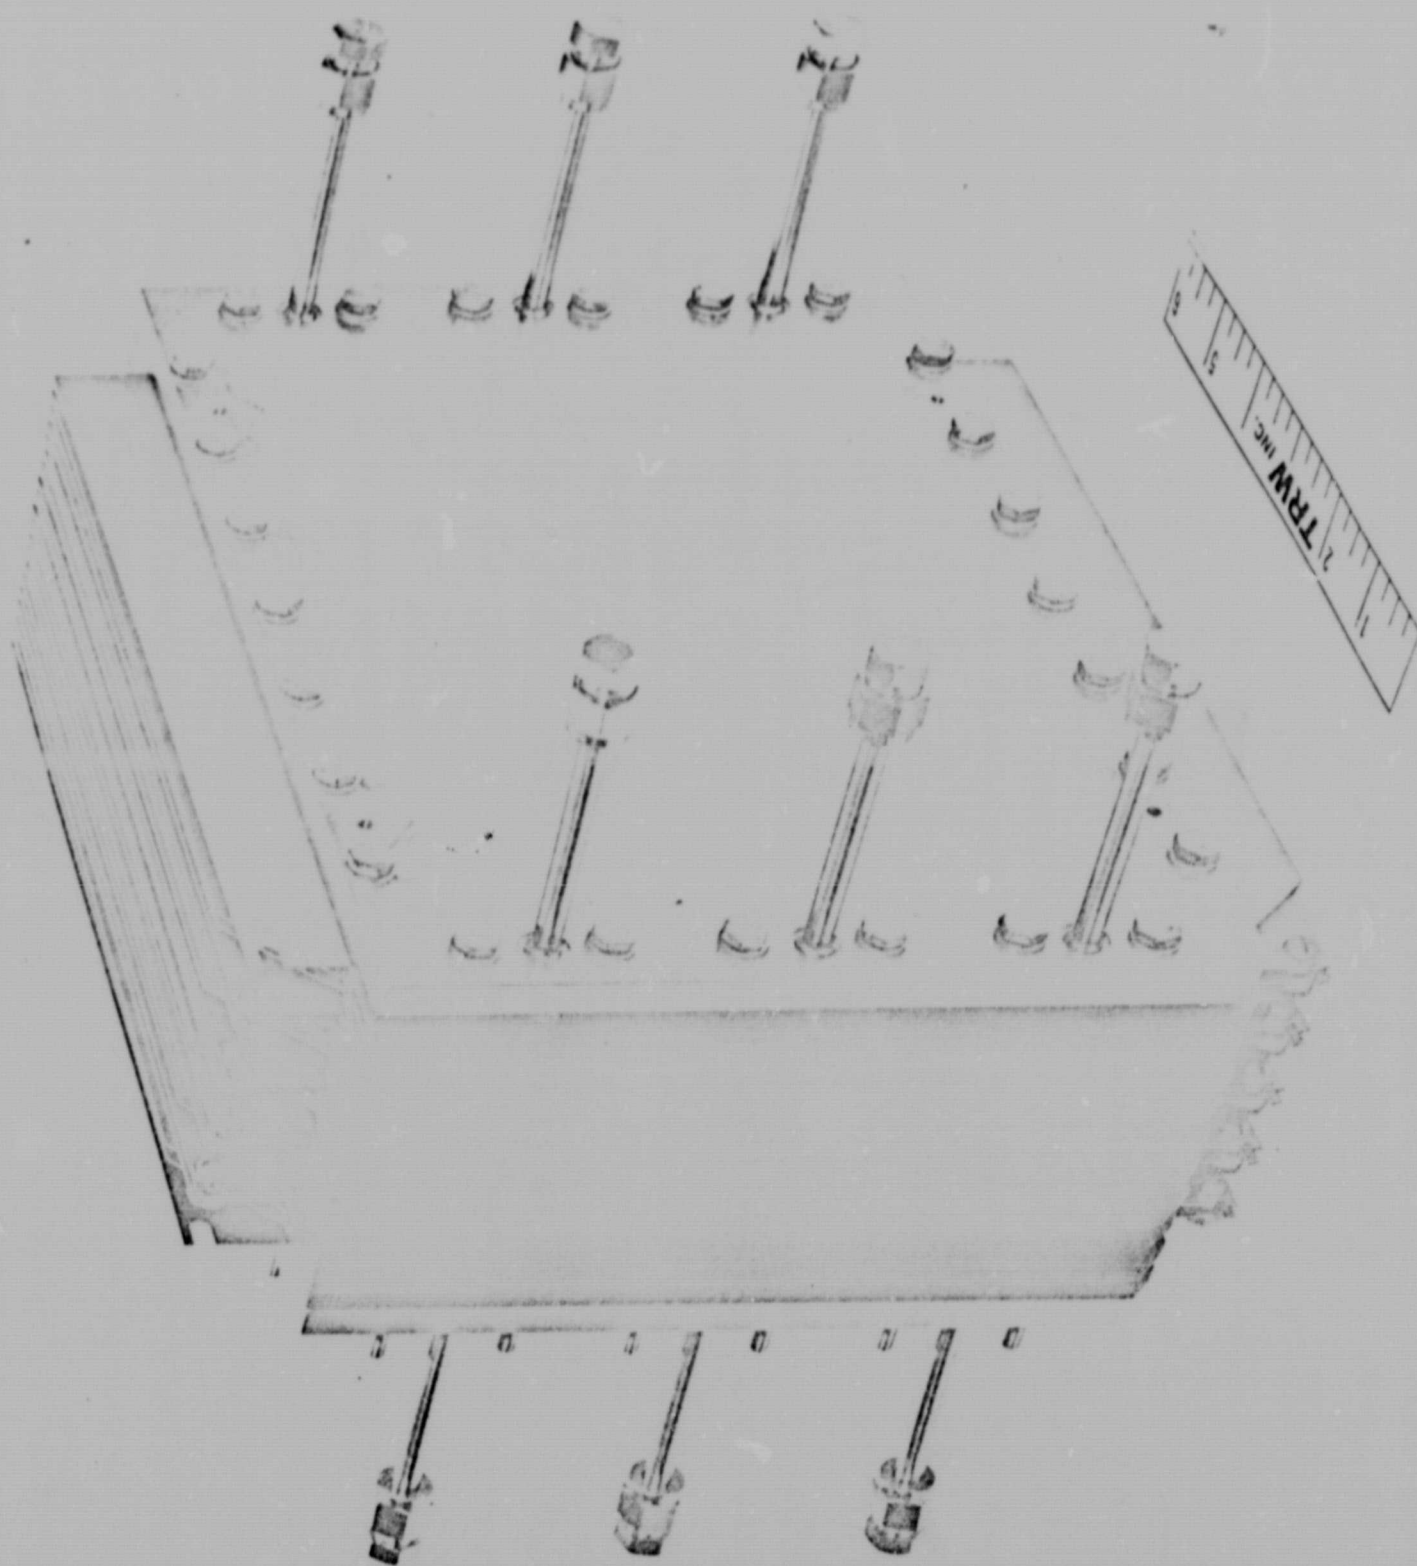
Figure 3 is a photograph of the assembled ten-cell Water Electrolysis Module. Only four manifold ports are required for operation. However, as can be seen from Figure 3, the module was equipped with extra ports to allow for increased flexibility in testing. Table 2 summarizes the characteristics of the WEM and cells.

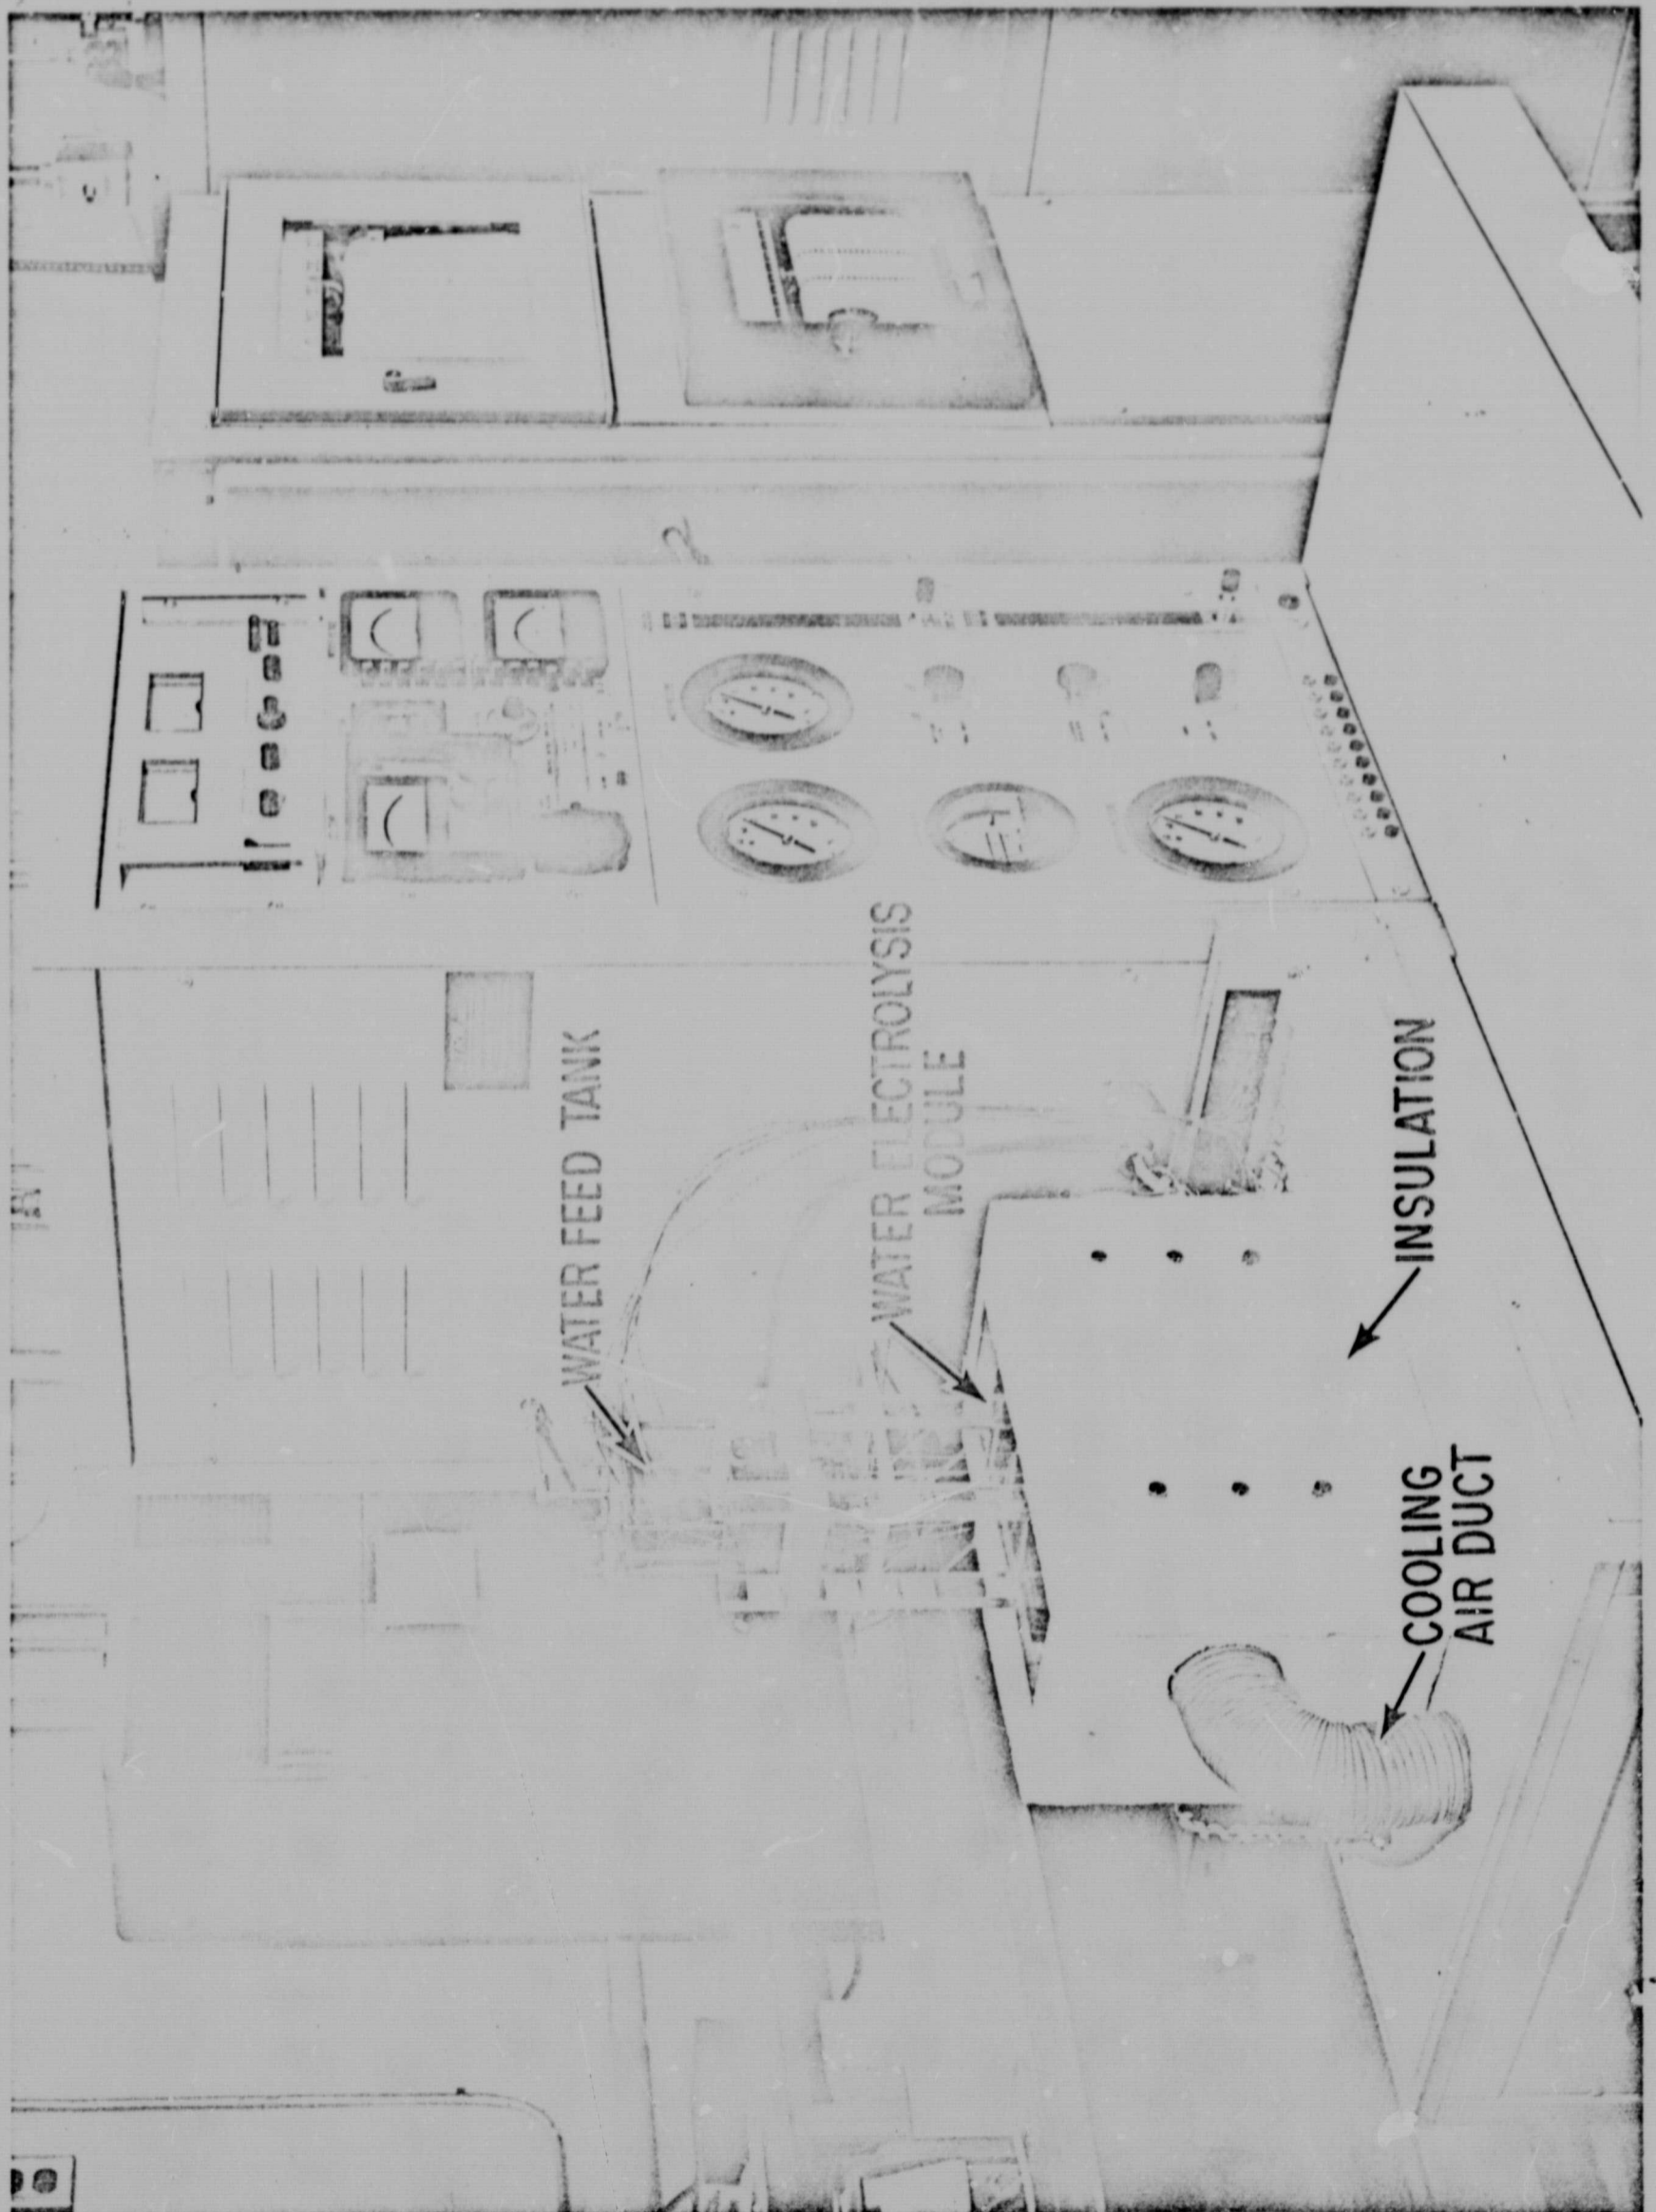
Figure 4 is a photograph of the test setup showing the insulated electrolysis module in place and under test. The right hand console contains the individual cell temperature and cell voltage recorders. Safety features of the test setup include automatic shutdown provisions for overpressure, over-temperature, pressure differential (H_2 to H_2O) out of range and overvoltage.

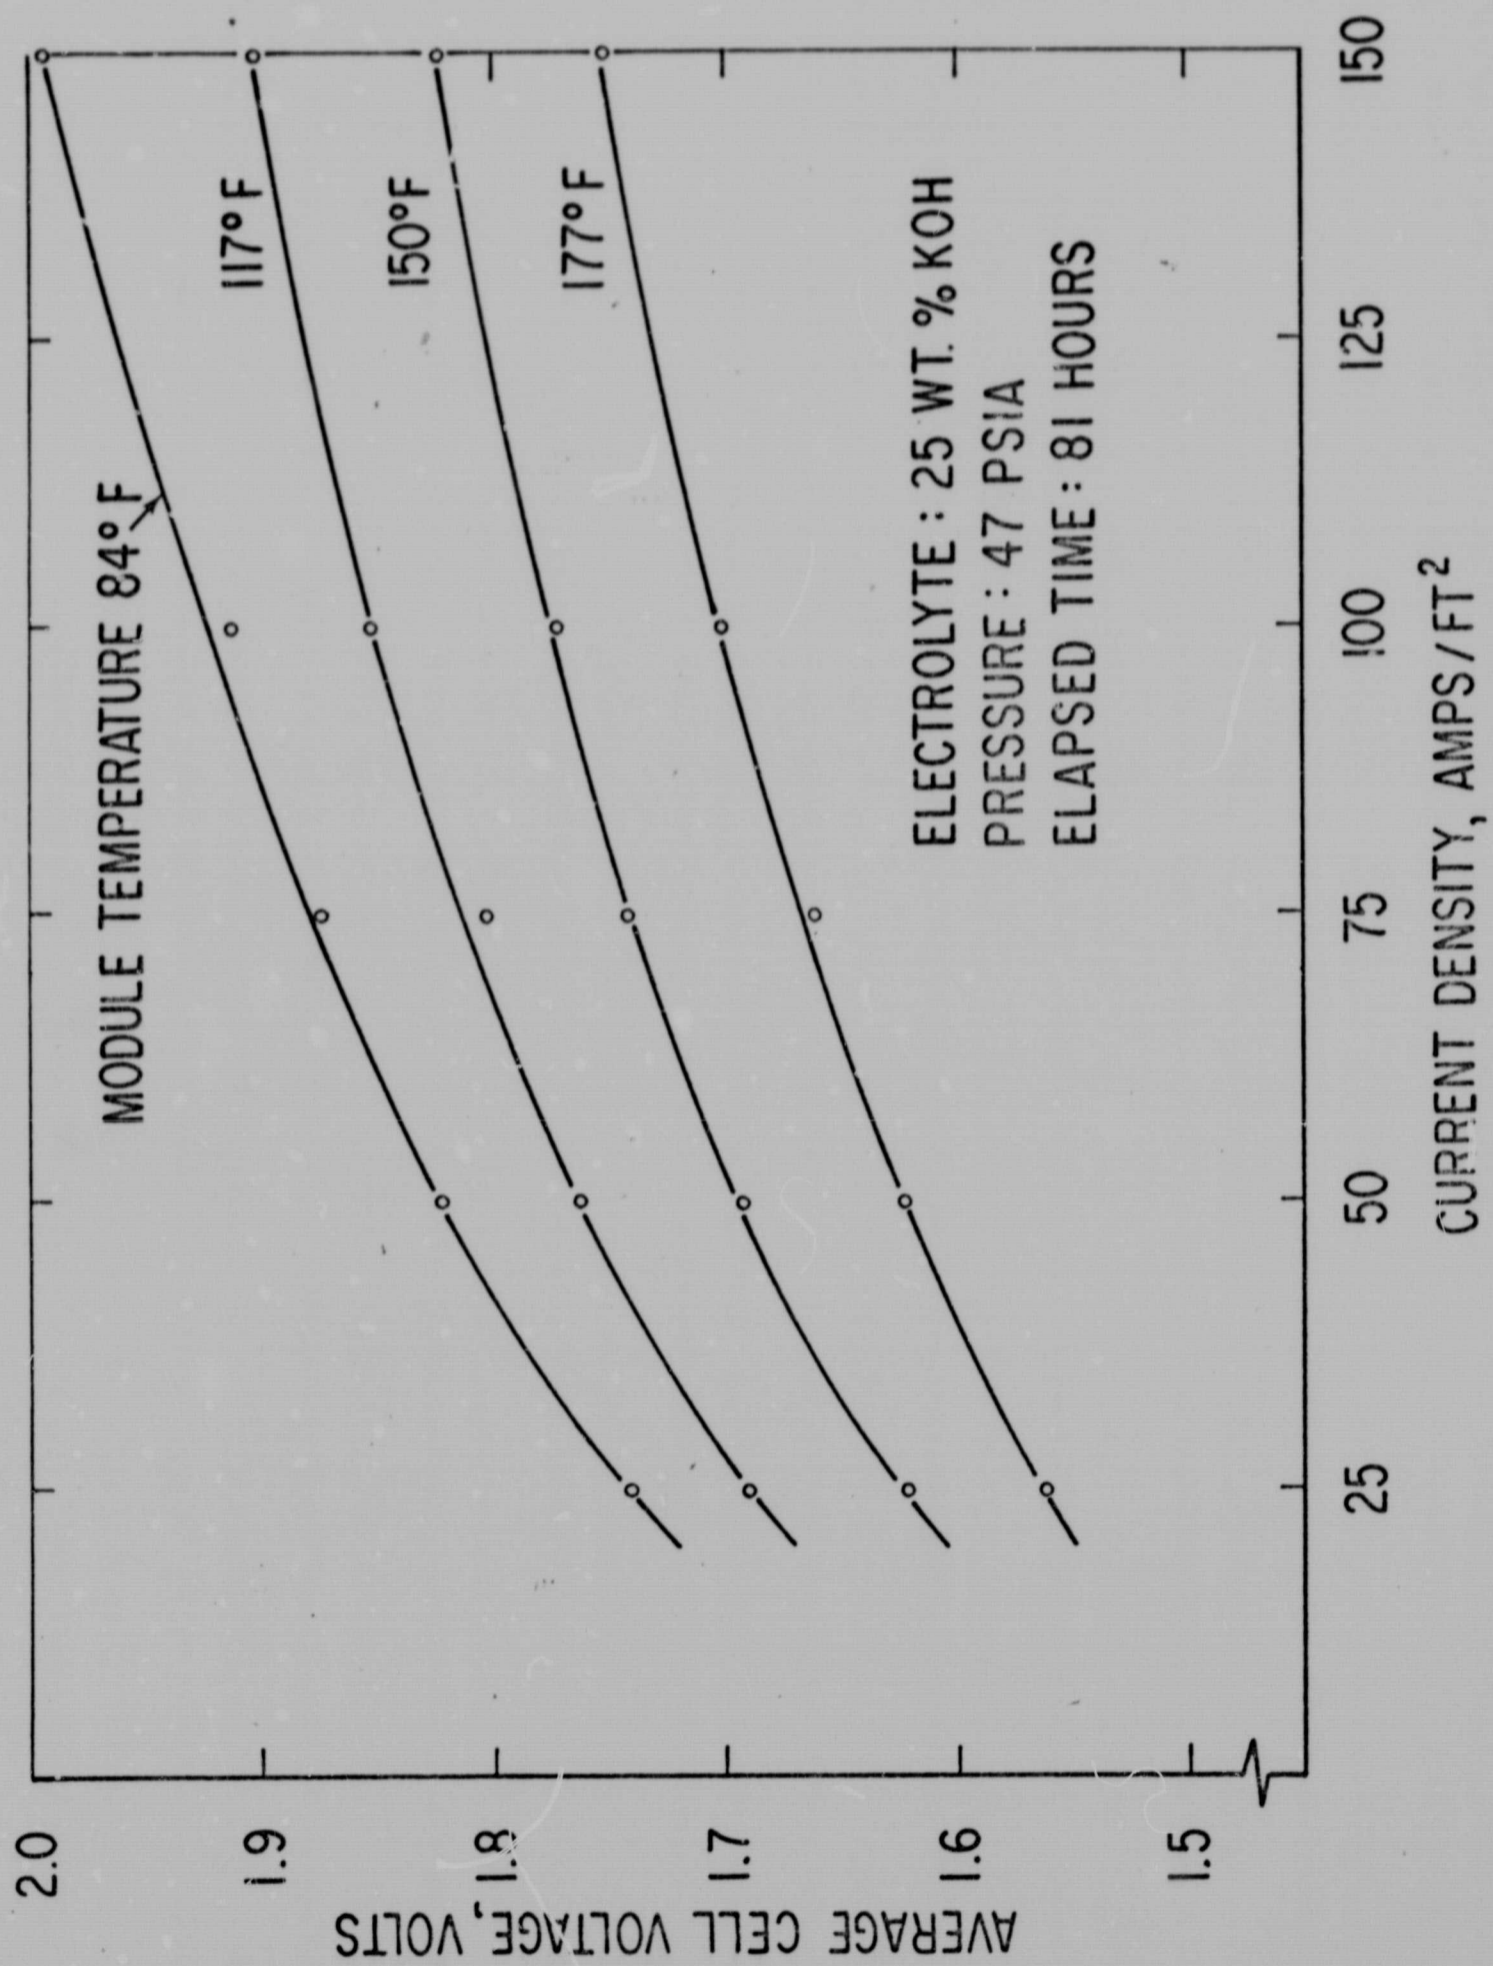
The data of Figure 5 demonstrates the effect of current density and temperature on cell performance. As can be seen, increasing the current density increases the cell voltage and increasing the stack temperature decreases the cell voltage. The data shown in Figure 5 was taken after 81 hours of operation and is representative of module performance during the parametric test phase.

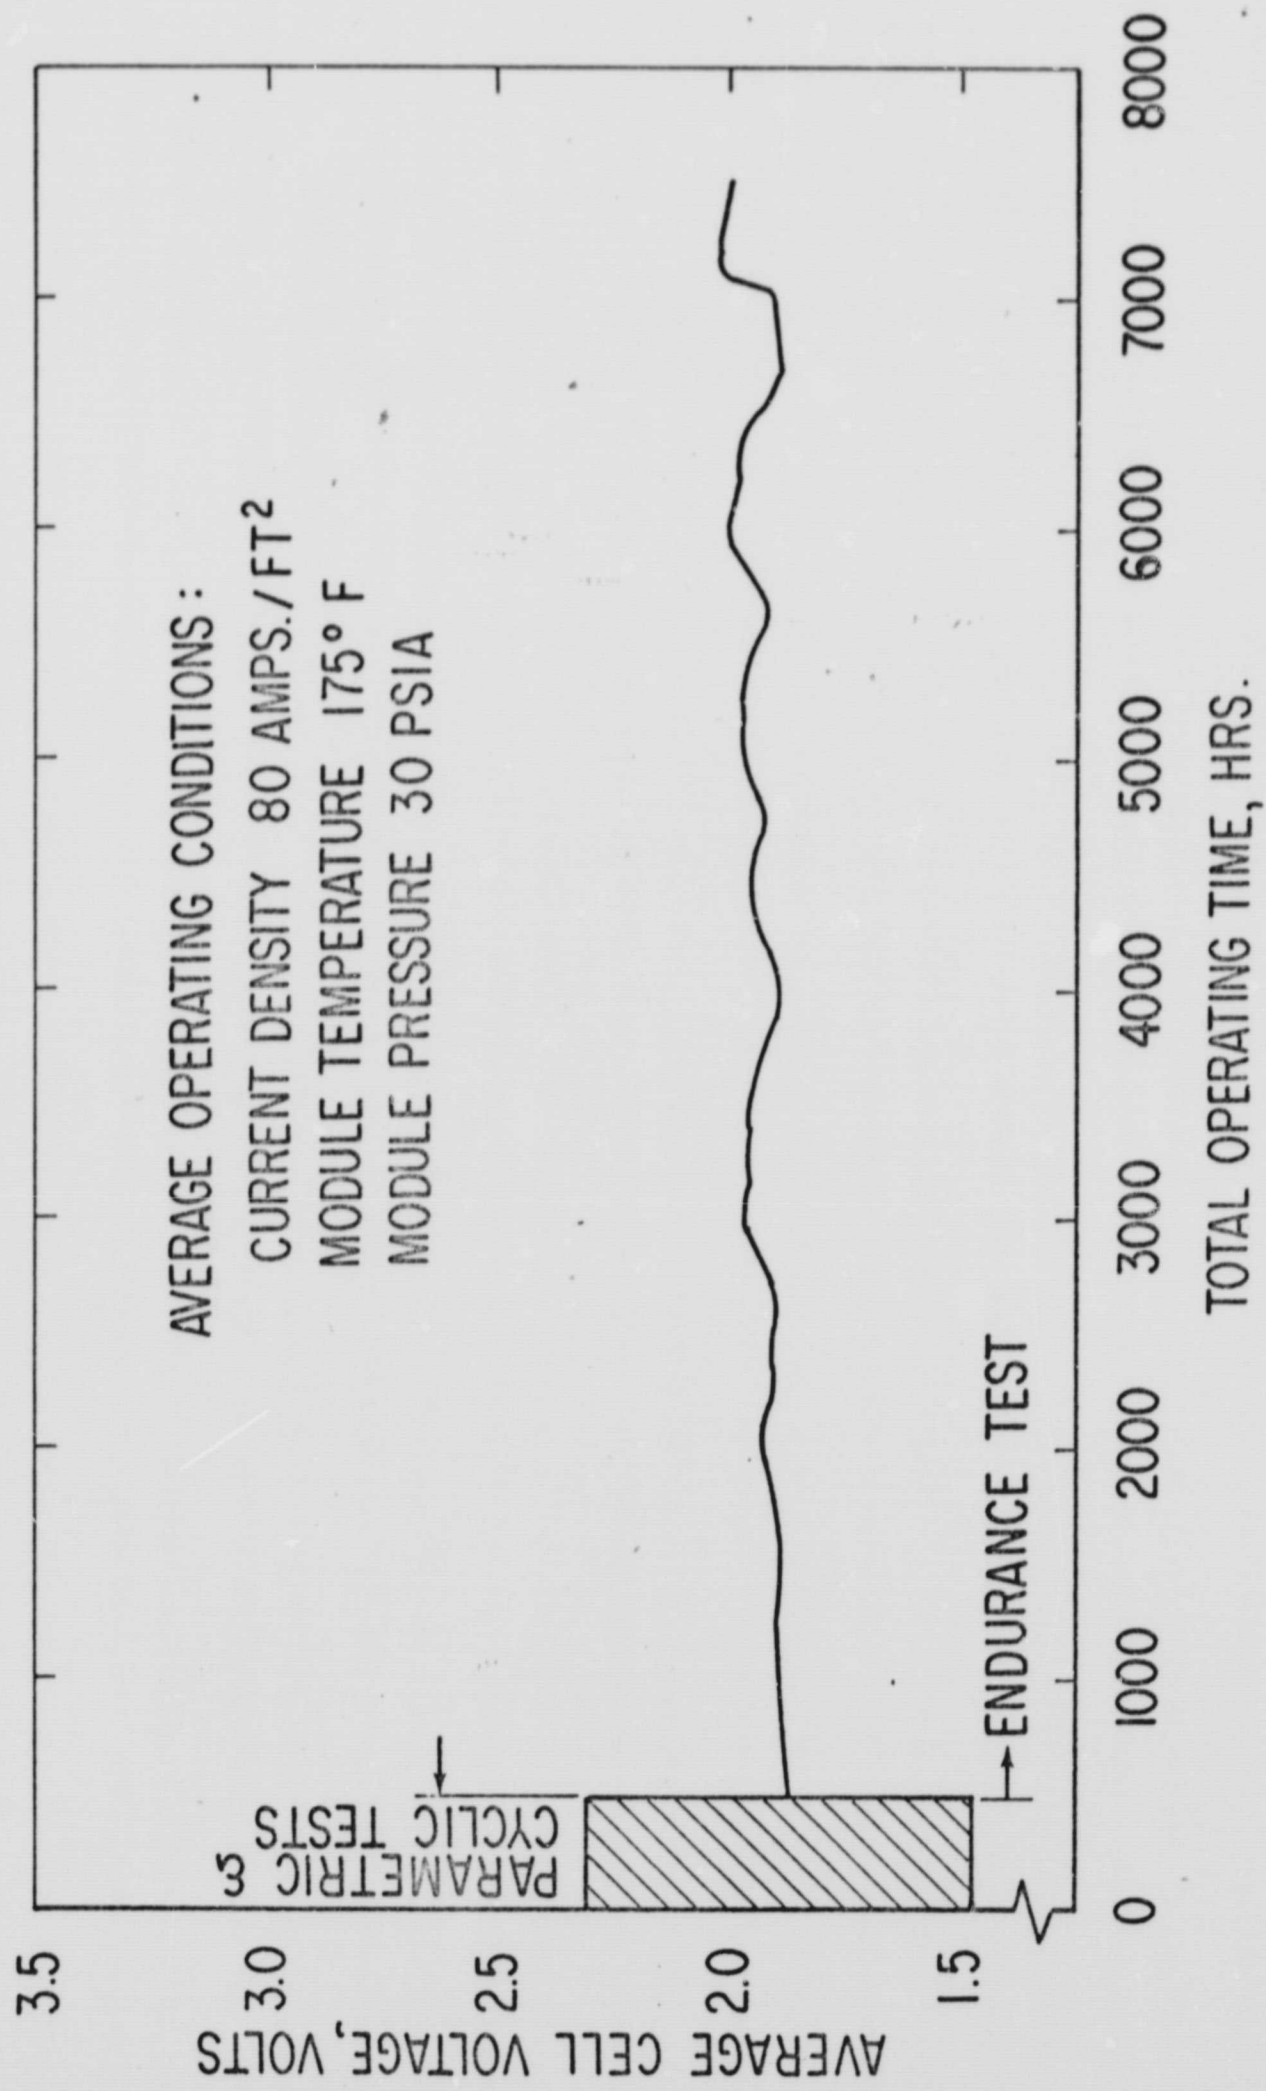
voltages. This cell voltage fluctuation can be observed both in Figure 6 and in Figure 7. In the latter figure, an improvement in cell performance is shown with time (comparing the performance curves after 2,500 and 6,671 hours of operation). Quantitatively, the increase in voltage of WEM #1 as a function of time can be expressed as an increase of 1.2 millivolts per hour for the first 250 hours of operation and 0.036 millivolts per hour for the next 2,500 hours of operation. Beyond this point in time the average voltage level remained constant.

2. Power requirements initially increase with time but then level out. There is an initial rapid rise in power (cell voltage) over the first 250 hours. This is followed by a slower rise over the next 2,500 hours after which time the voltage remains level. From then on the voltage fluctuates around this level due to the module's response to variations in test rig, servicing, and operator performance. The amplitude of the fluctuations tends to increase with time. The quantitative values of voltage increase with time were 1.2 millivolts per hour for the first 250 hours of operation and 0.036 millivolts per hour for the next 2,500 hours of operation. Beyond these hours, average cell voltage remained constant. These voltage variations were obtained at a current density of 80 amps/ft².

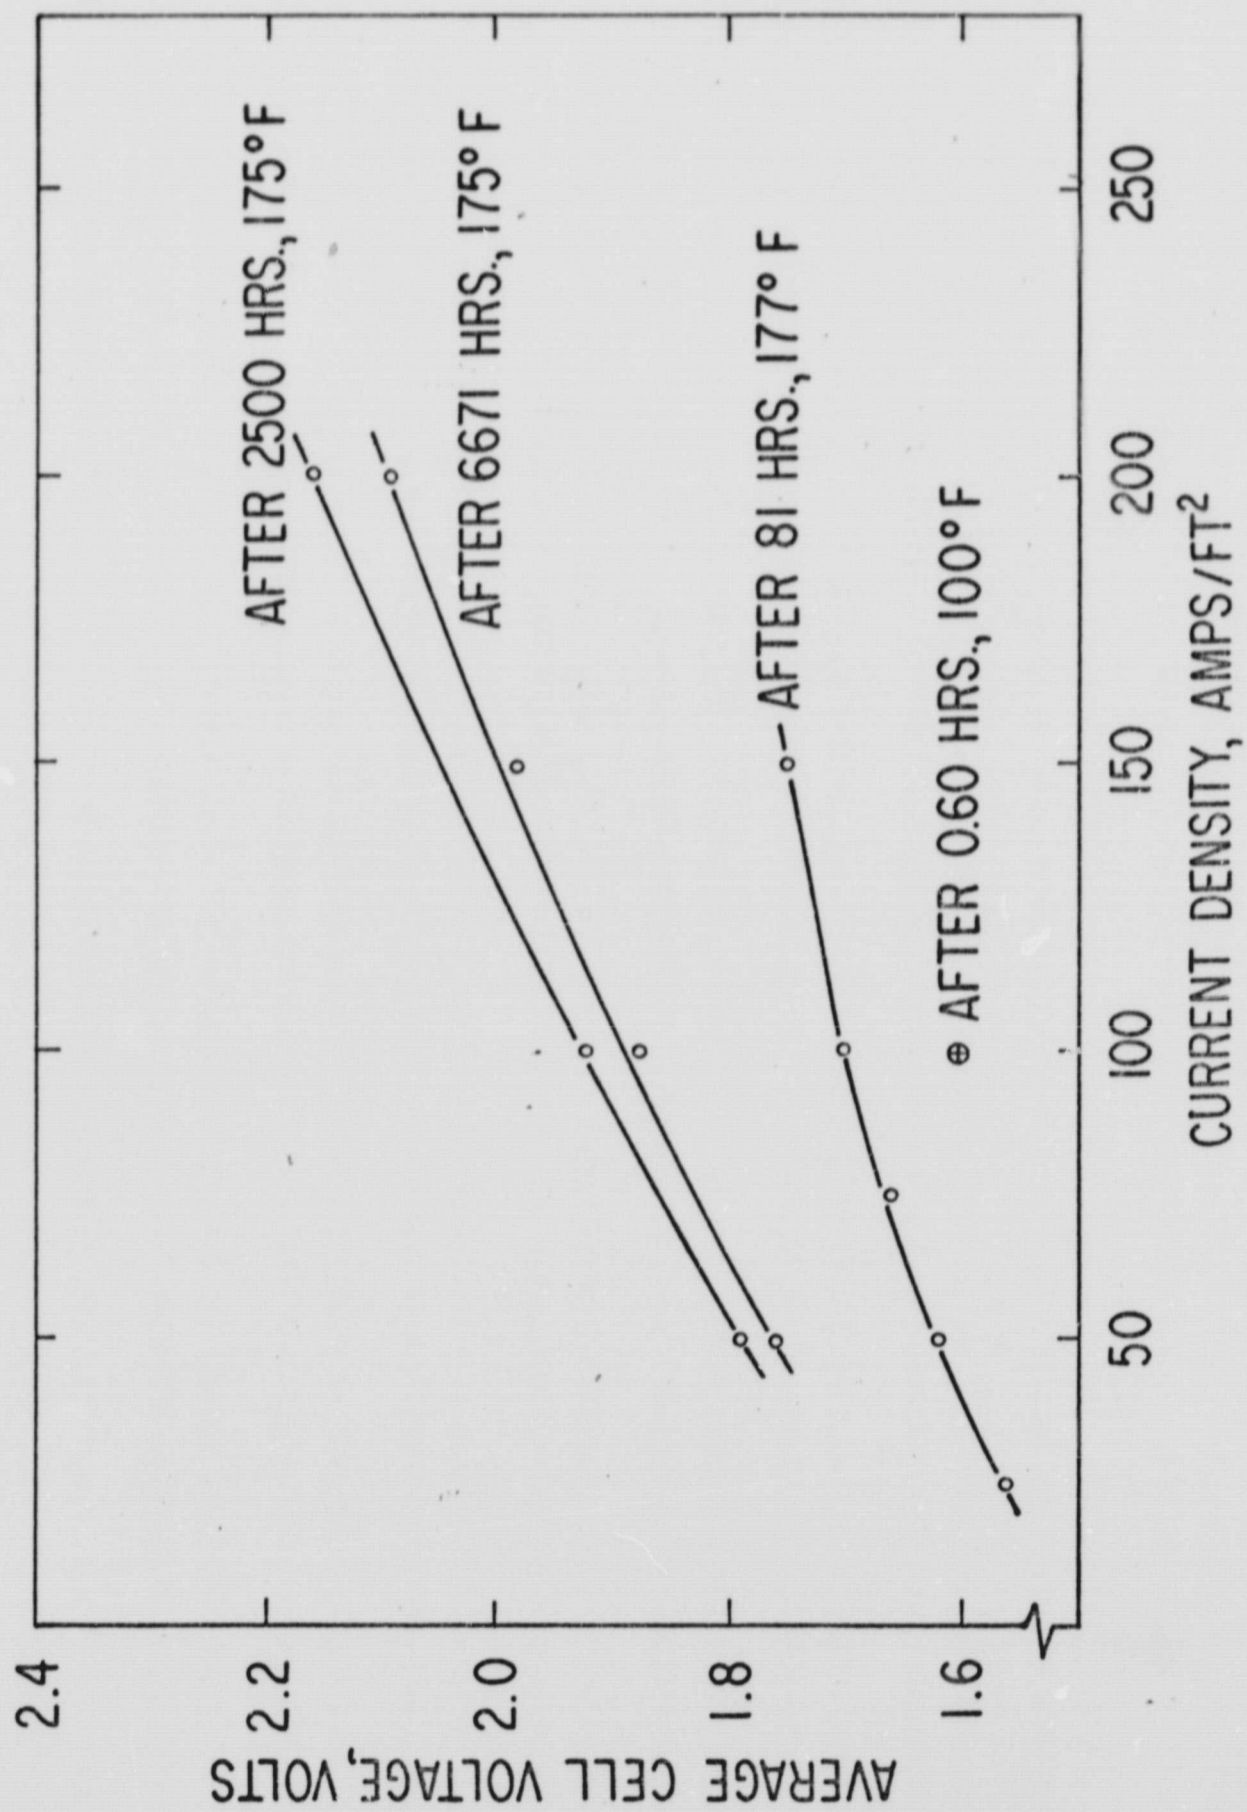
Figure 7 shows the average cell voltage of WEM #1 as a function of current density taken after 0.6, 81, 2,500 and 6,671 hours of operation. An initial degradation in cell performance is experienced but it levels off with time. Slight fluctuations in cell voltages will occur as a function of time since such factors as test rig and module servicing and/or maintenance affect cell
